# Preliminary Site Investigation – 139 Grange Road, Burnham

✦ Prepared and updated for  
Burnham 2020 Ltd

✦ July 2023

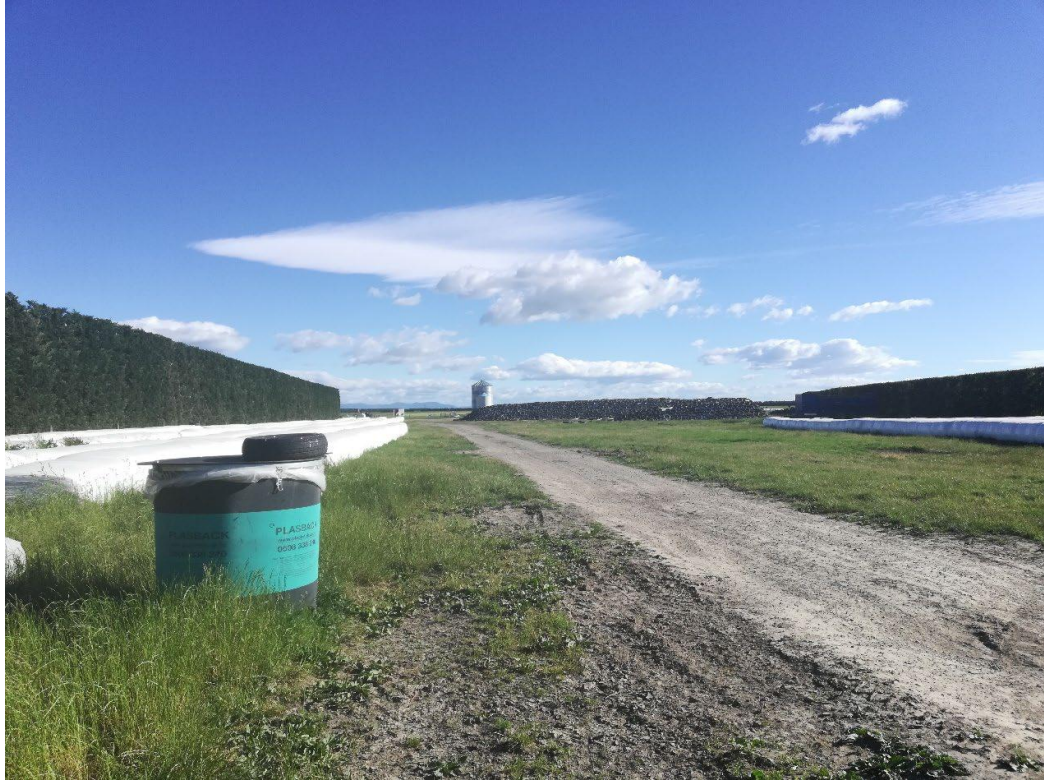
**Photograph 1: (View north from the yard looking towards the silos)**

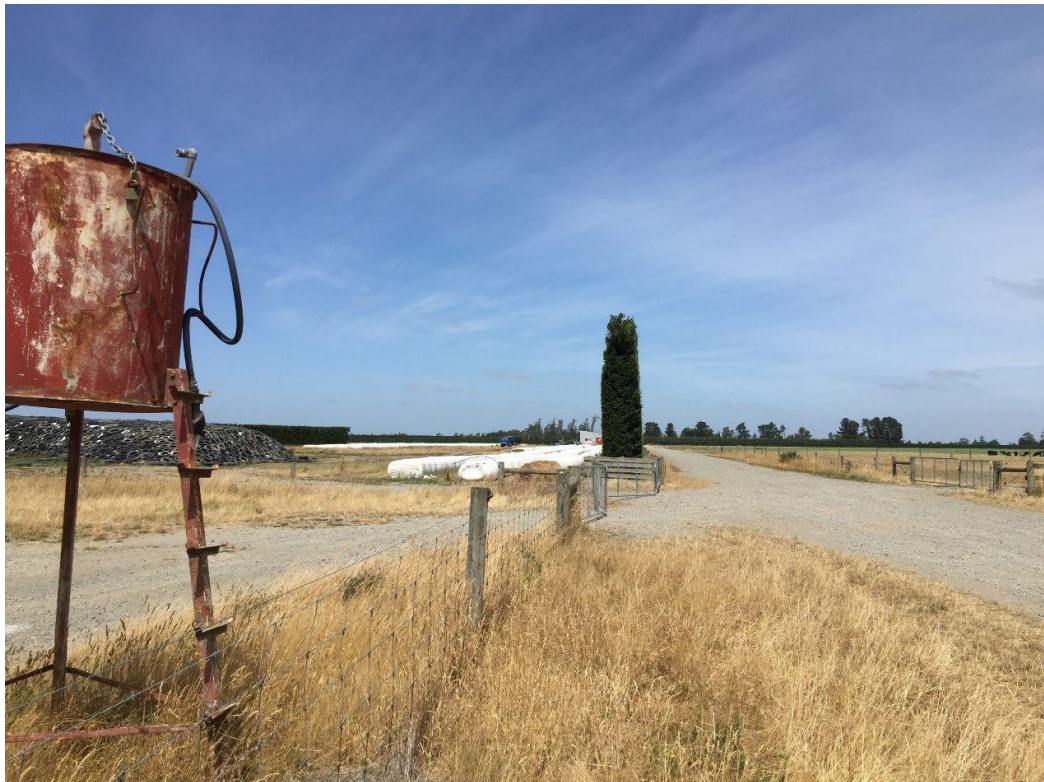
**Photograph 2: (View south towards the entrance of the site and the yard (historical fuel tank in left field of view))**

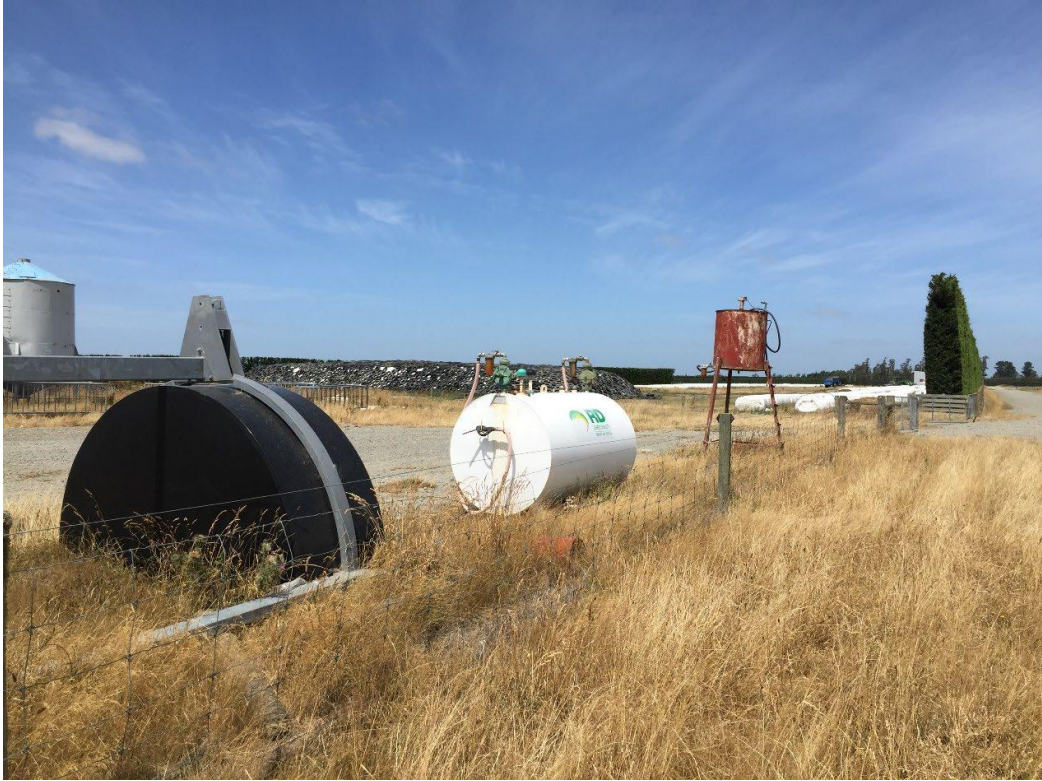
- ∴ Two shipping containers are located approximately 50 m north of the barn, with one container marked as containing anhydrous ammonia (fertilizer);
- ∴ In the centre of the site, approximately 200 m north of the barn are two above ground fuel storage tanks. One is an old disused diesel fuel tank and the other the current tank used to fuel the farm vehicles on site. There was no obvious significant staining on the surface surrounding these tanks;

**Photograph 3: (Fuel storage tanks, historical (red tank) and current (white))**

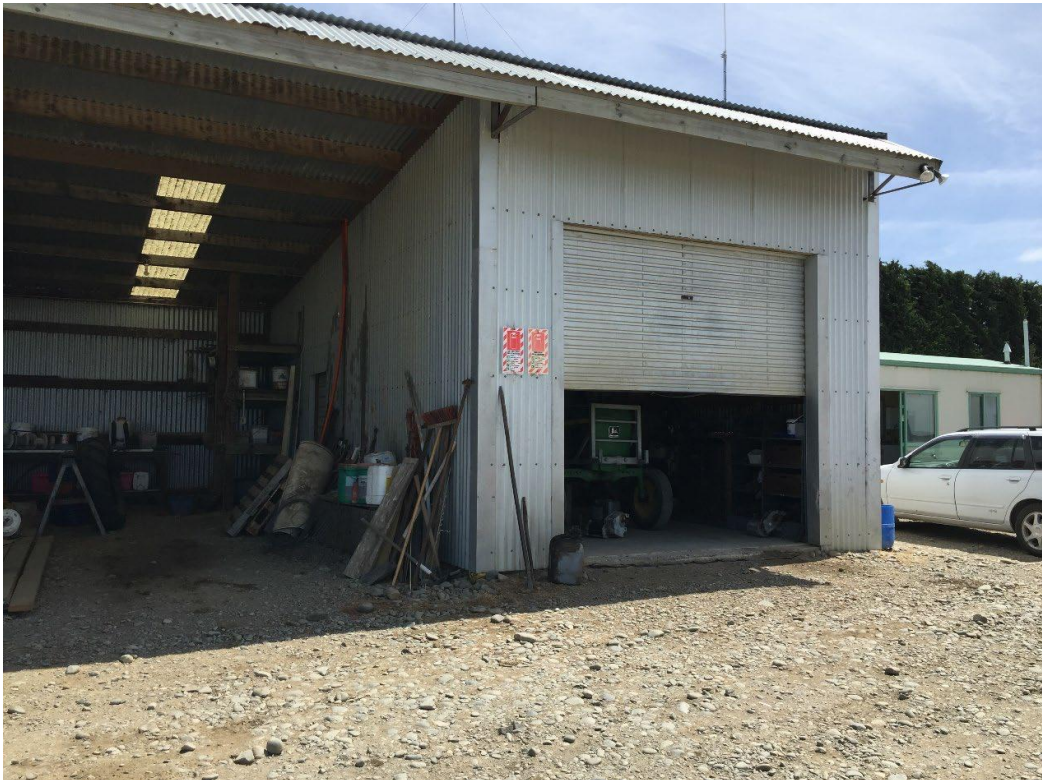
**Photograph 4: (View of the northern side of the barn and mechanics workshop)**

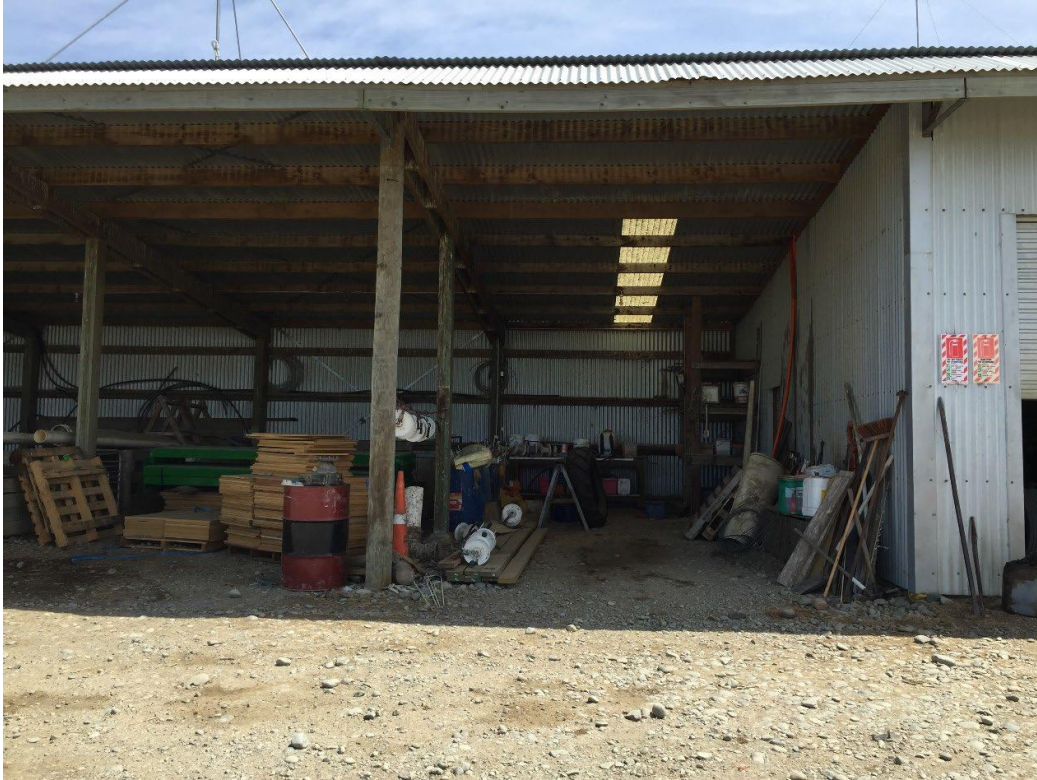
- ∴ One main barn of corrugated iron construction is located in the central portion of the site associated with the current farming operations. The southern end of the barn is currently used for the storage of general farming materials/consumables and vehicles including tractors. This portion of the barn is unsealed and some minor hydrocarbon staining was observed on the ground surface. This was considered typical for normal farming operations where equipment is stored. The northern end of the barn is used as a vehicle workshop and has a concrete surface. A hazardous storage cupboard with signage (2WE – Agrichemicals) was evident in the workshop;

**Photograph 5: (Inside of barn showing storage of various materials and some hydrocarbon staining on sandy gravel surface)**

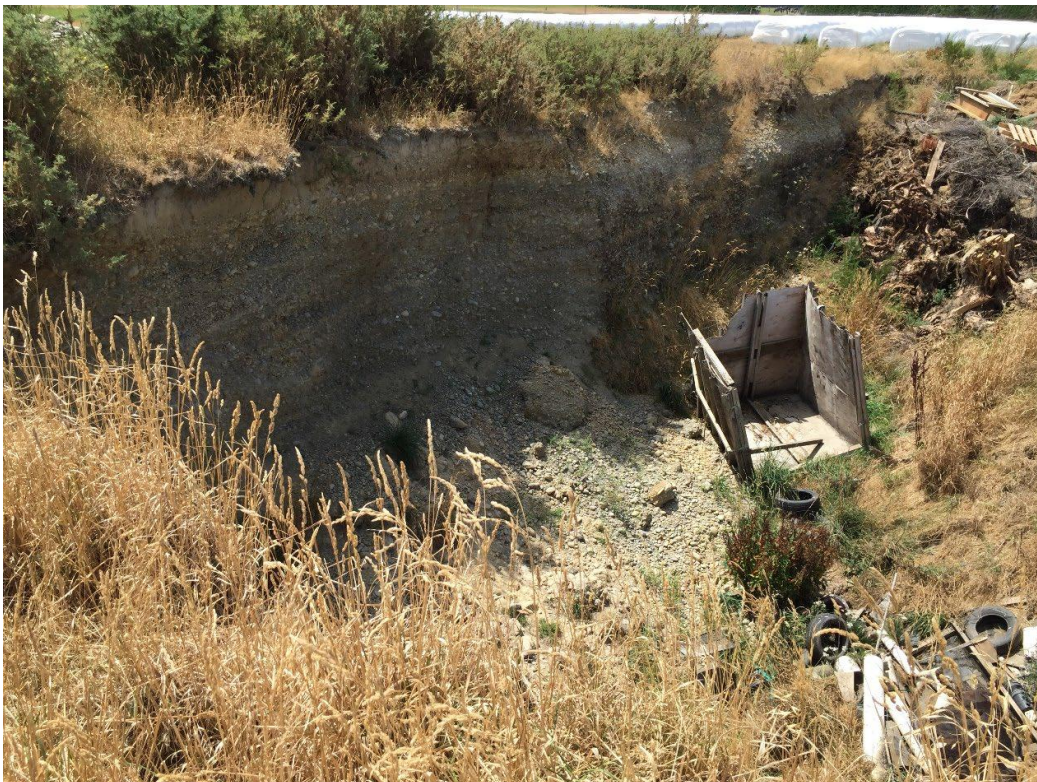
- ∴ Waste pits/infill pits have been identified at the site. The current farming waste pit was observed during the site inspection and contained organics, metal, concrete, plastics and wood waste. The full composition and extent of the material in the pit is unknown. It is understood that future pits will be used in the general area. The composition of the material within the former infilled pit is unknown. Other pits may also exist across the site associated with general farming practices.

**Photograph 6: (Current waste pit looking north-east, showing soil profile on northern edge of pit and waste material including wood, organics and tyres)**

The recommended approach to manage the identified contamination sources is to undertake targeted detailed site investigations of each HAIL area as the quarry development progresses (i.e. immediately prior to disturbance of these identified areas). This will ensure that any contamination sources associated with the ongoing use of the site as production land is captured in the assessments. The results of the testing will determine the appropriate course of action that is required and what remedial works, if any, are required. This would be outlined in a Site Management Plan prepared for the quarry development works.

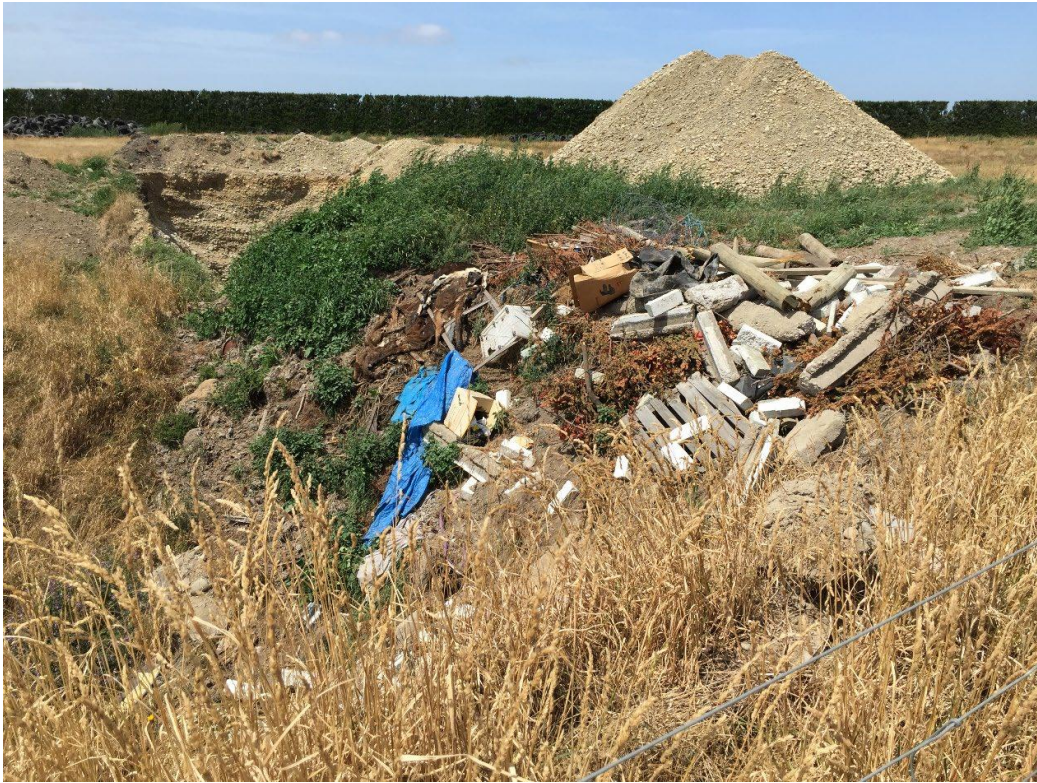
**Photograph 7: (Close up of waste material, including dead stock)**

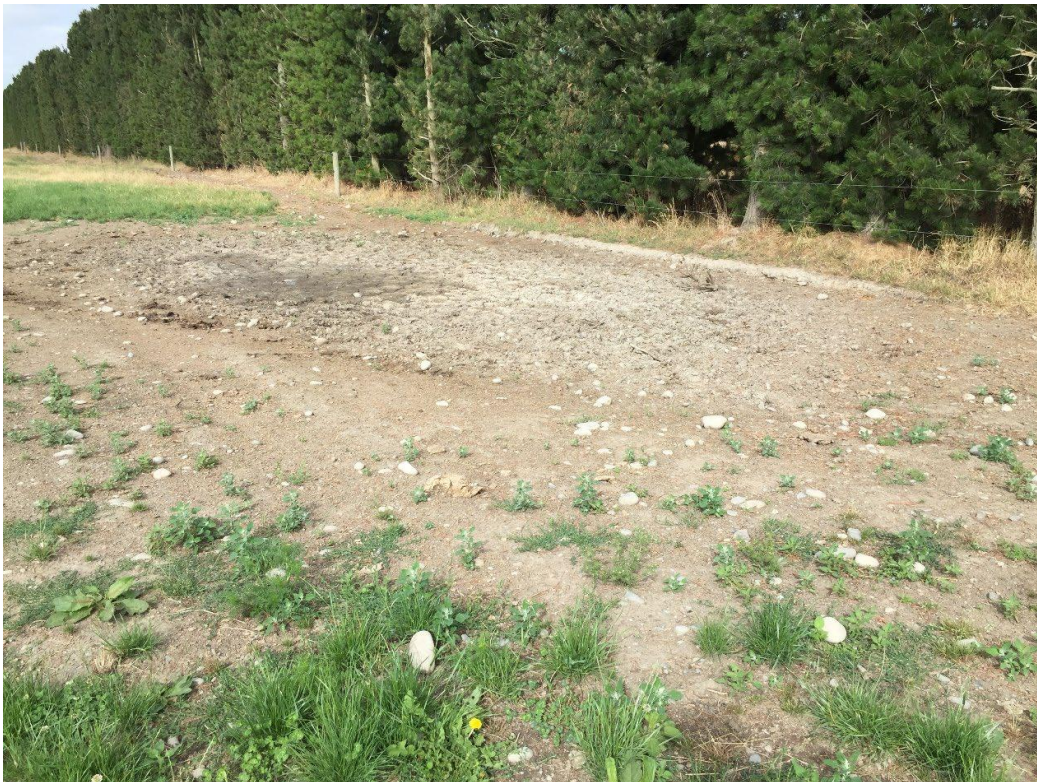
**Photograph 8: (Disturbed ground/depression shown on western boundary of site where former waste pit is located)**

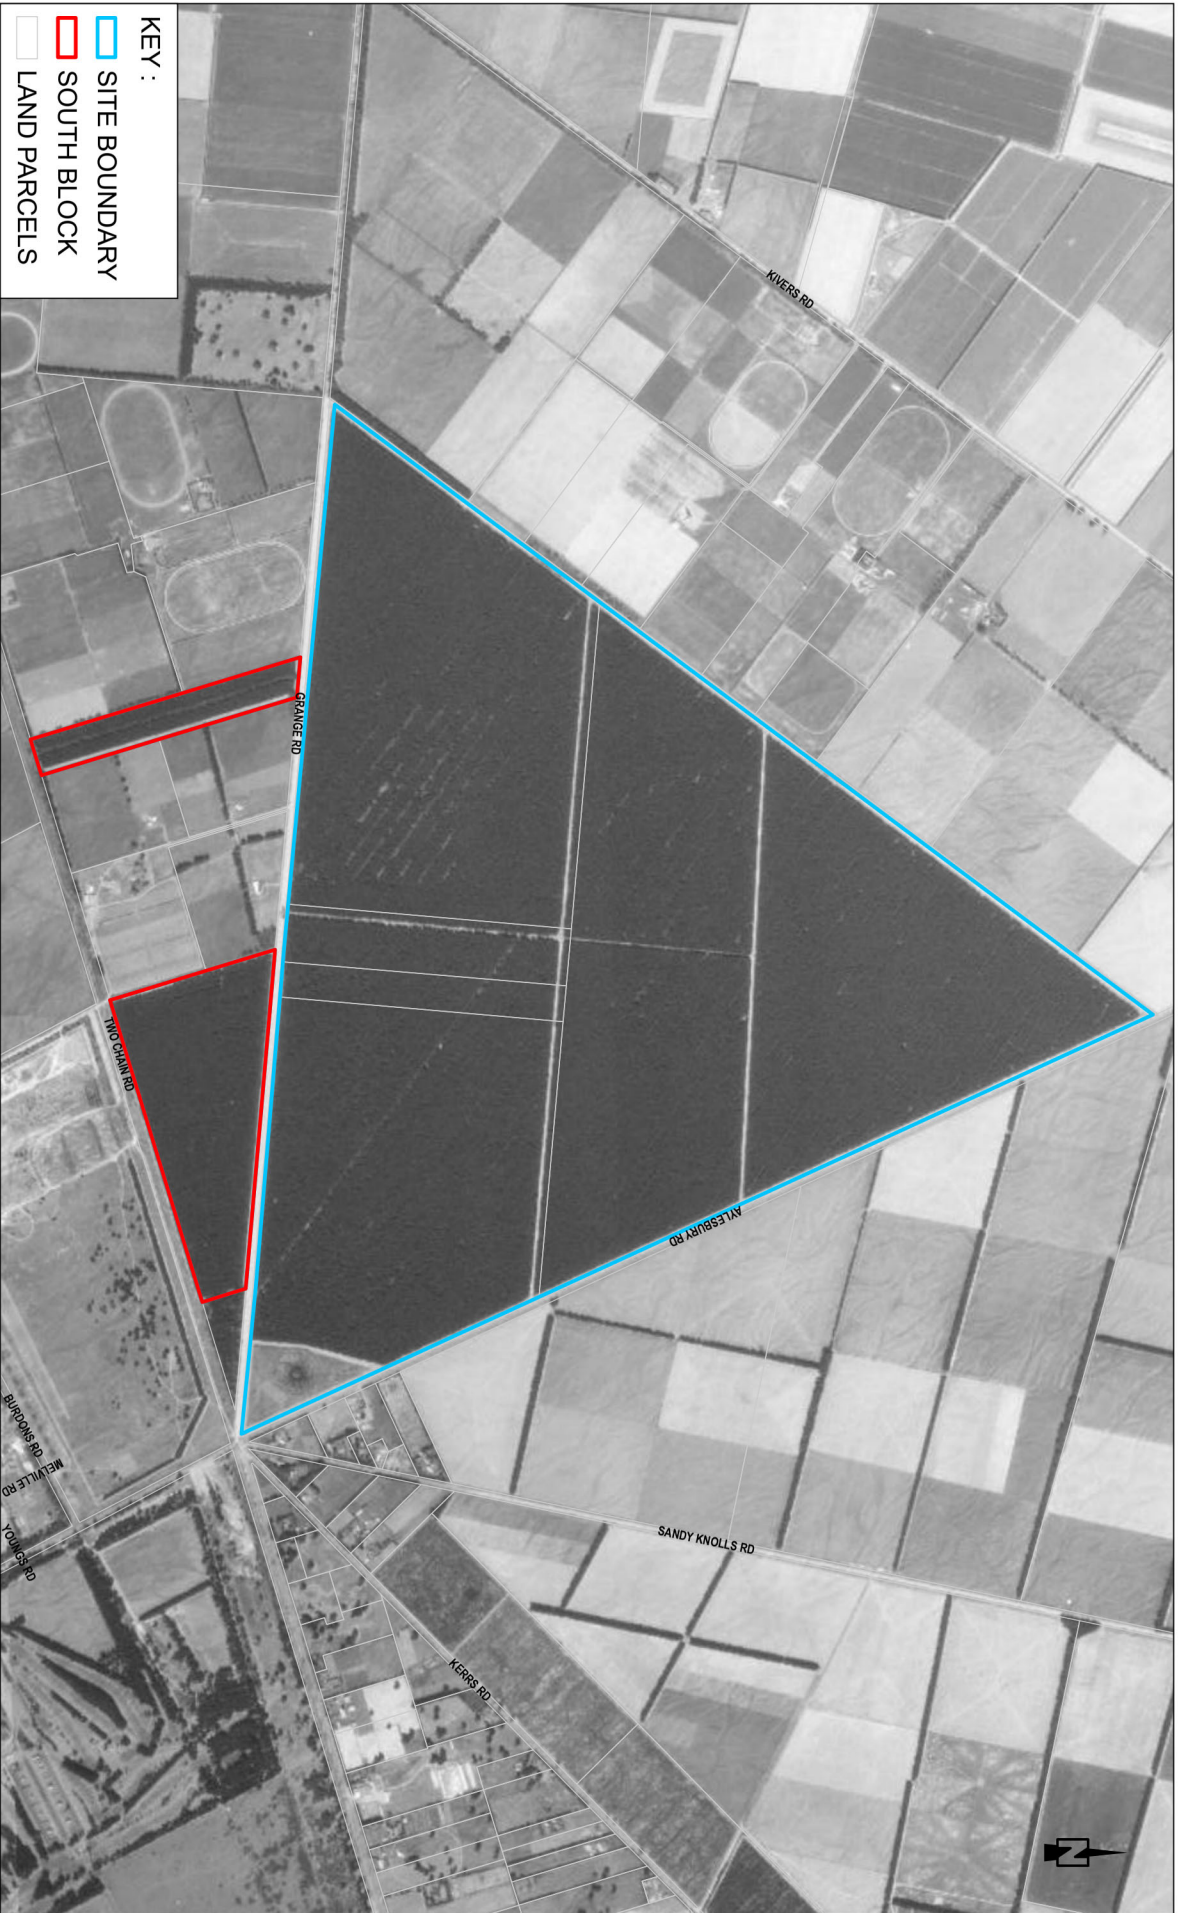
AERIAL PHOTOGRAPH: 1994

1994	The site has been replanted with forestry. A circular area of trees is visible in the location of the former farmhouse.
2004	The trees have been harvested across the site, with loading out areas and tracks visible. Pounded water is present in numerous areas across the site, particularly within loading out areas and the access tracks. Large ponded areas are noted centrally on the site and on the western boundary. It is unknown if these may have been pits.

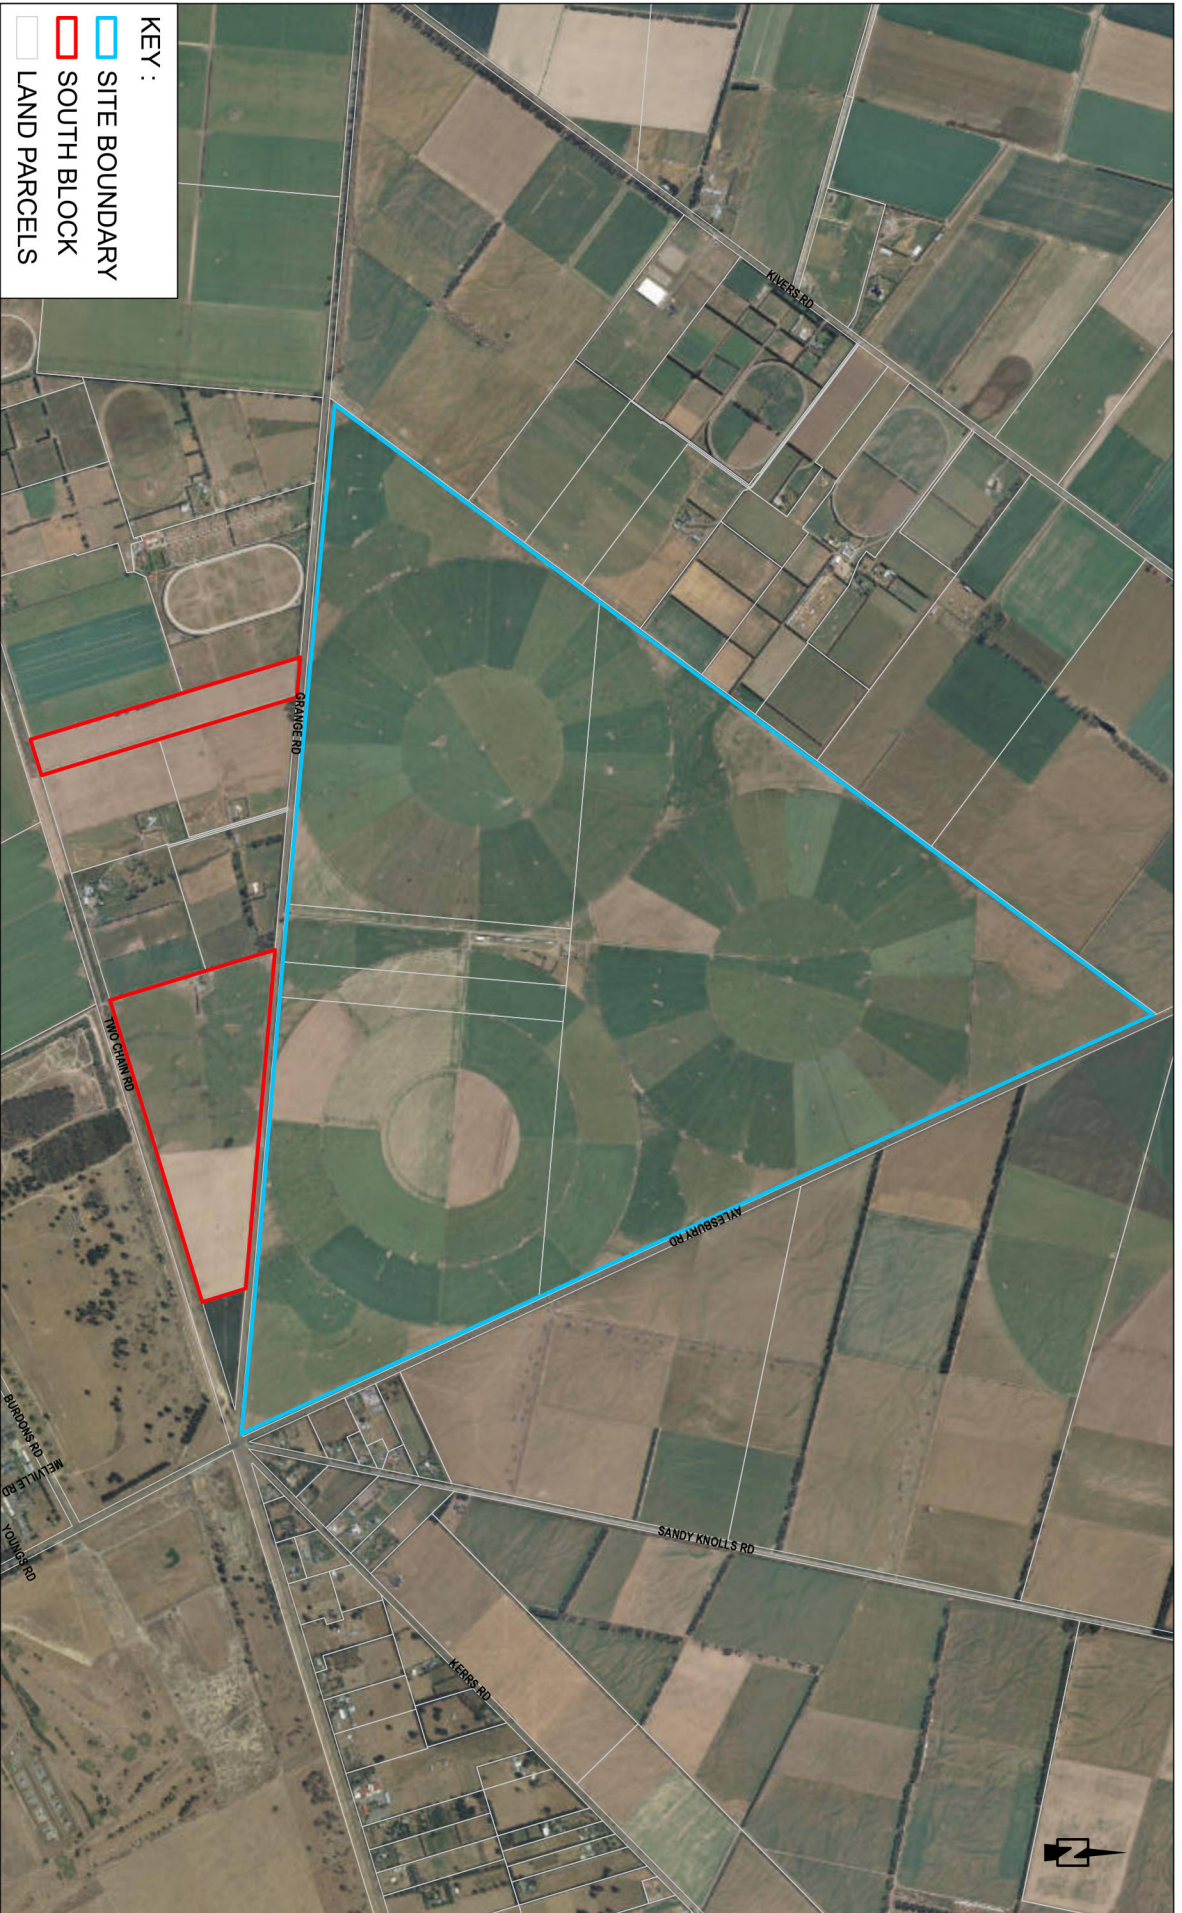
AERIAL PHOTOGRAPH: 2015-16

Table 2: Historical Aerial Photographs	
<b>2015-16</b>	The property has developed into its current layout, with the positions of the three main pivots across the site clearly visible. The current yard is also visible in the southern central section of the site. The current waste pit can be seen next to the two silos located in the centre of the site. 100’s of used tyres can be seen in the yard area (used for covering the silage stockpiles) with volume estimated to be less than 20 m <sup>3</sup> .
<b>2022</b>	The property remains in its current layout. No significant changes are identified.
<p><i>Notes:</i></p> <ol style="list-style-type: none"> <li><i>1. Historical aerial photographs sourced from Canterbury Map Partners, administered by ECan.</i></li> <li><i>2. It should be noted that some aerial images are at a large scale and therefore of relatively low quality.</i></li> </ol>
