Assessment of Soil Related Effects for Burnham Quarry

Burnham 2020 Ltd

✦ July 2023

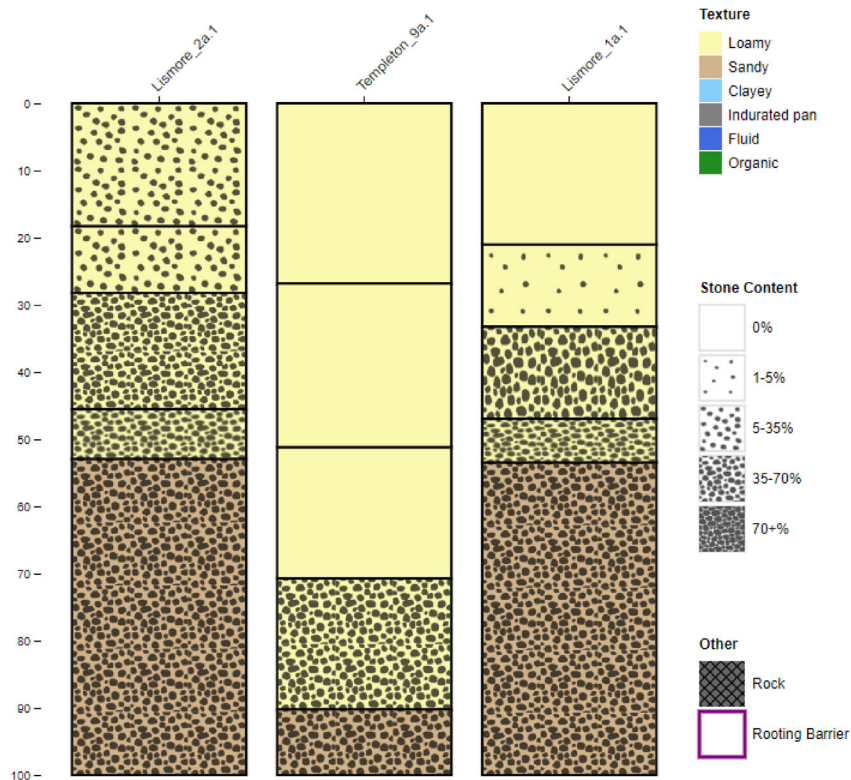
Figure 1 Texture of Soil siblings for the site

Figure 1 shows the texture profile of the siblings found in the map unit. Each horizon is coloured according to its texture (source [Soil map unit factsheet \(landcareresearch.co.nz\)](http://Soil map unit factsheet (landcareresearch.co.nz)))

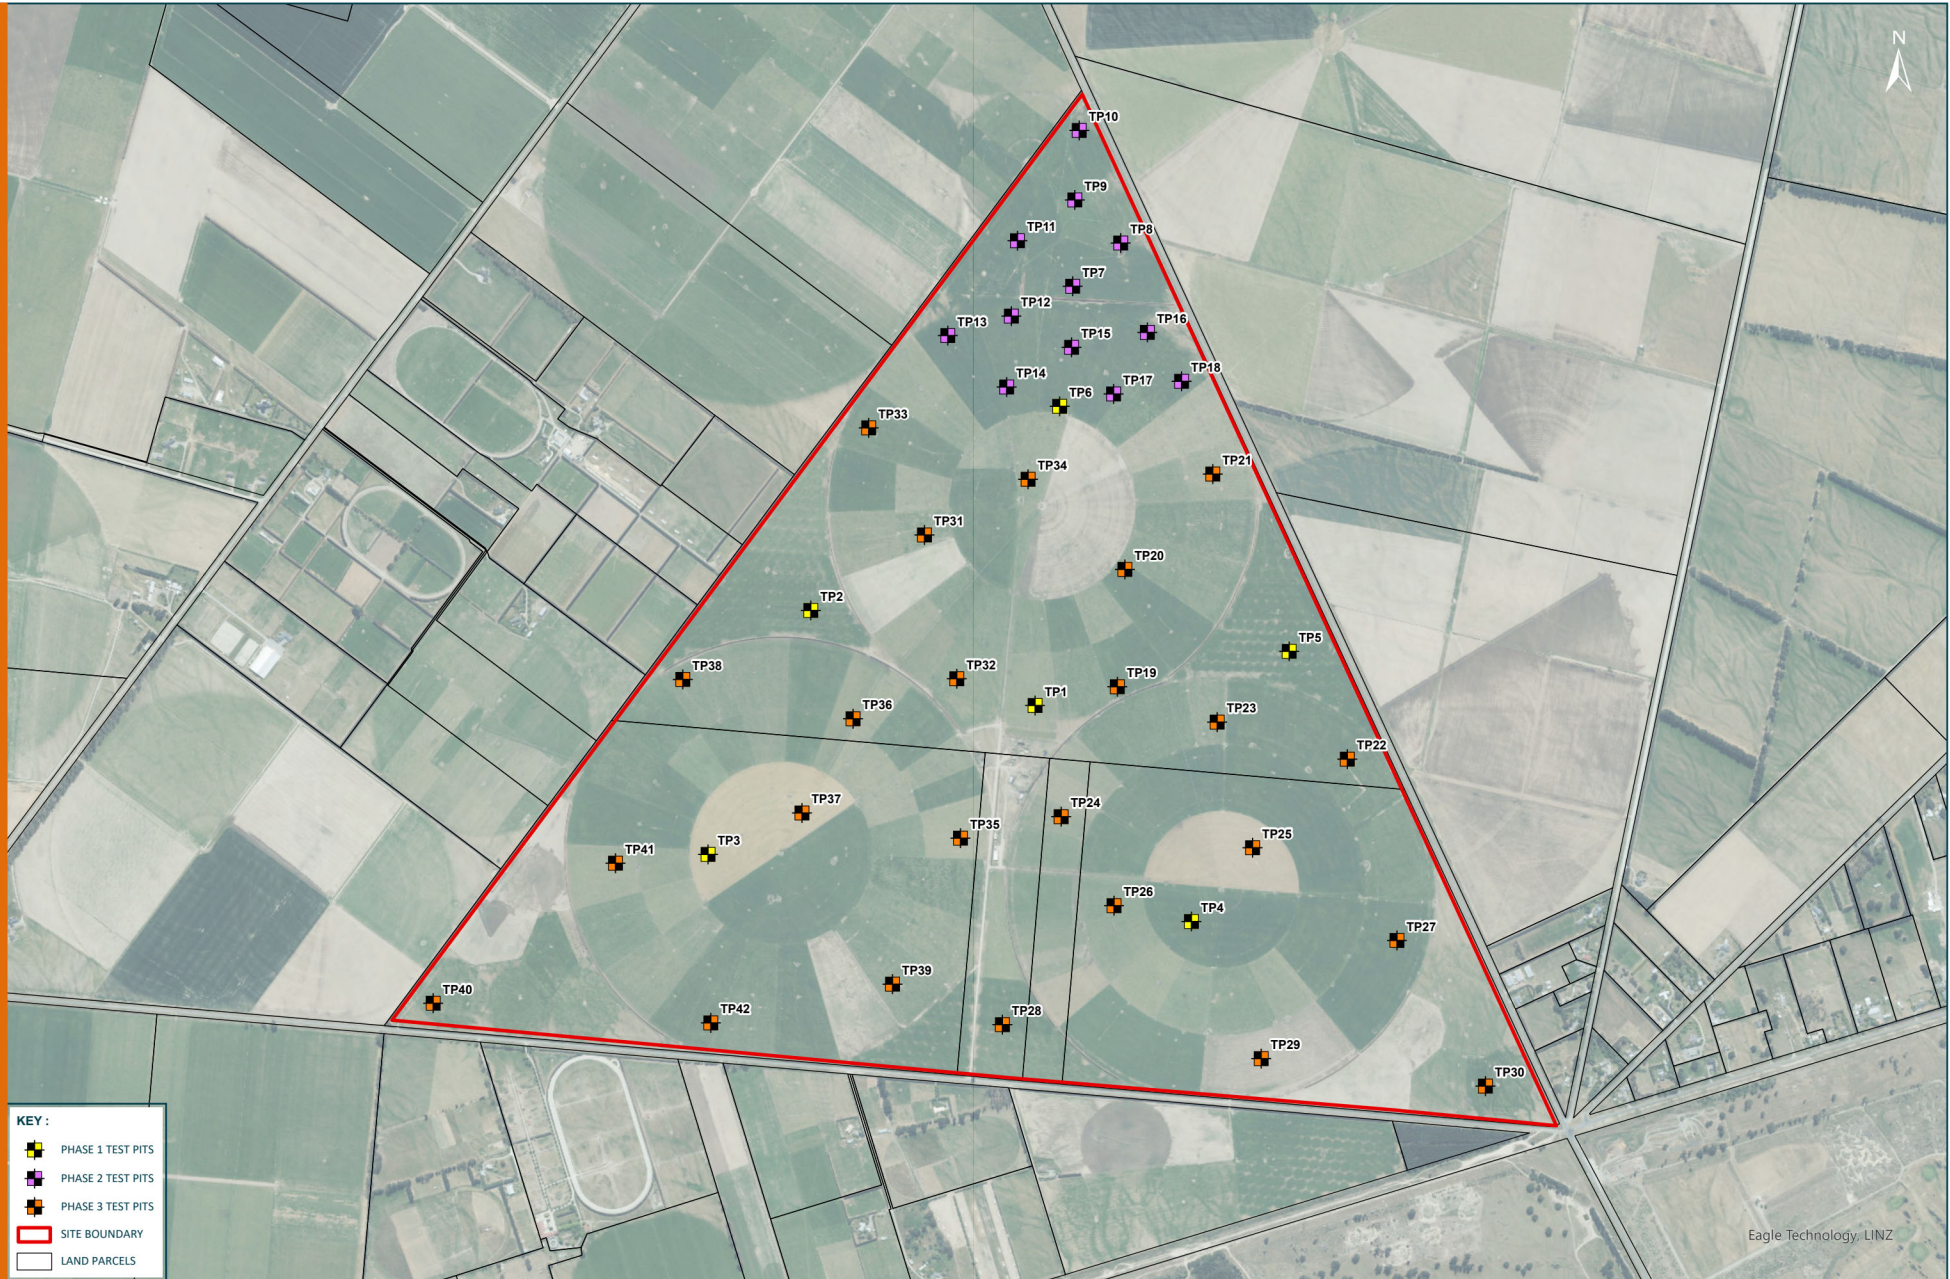
- PHASE 1 TEST PITS
- PHASE 2 TEST PITS
- PHASE 3 TEST PITS
- SITE BOUNDARY
- LAND PARCELS

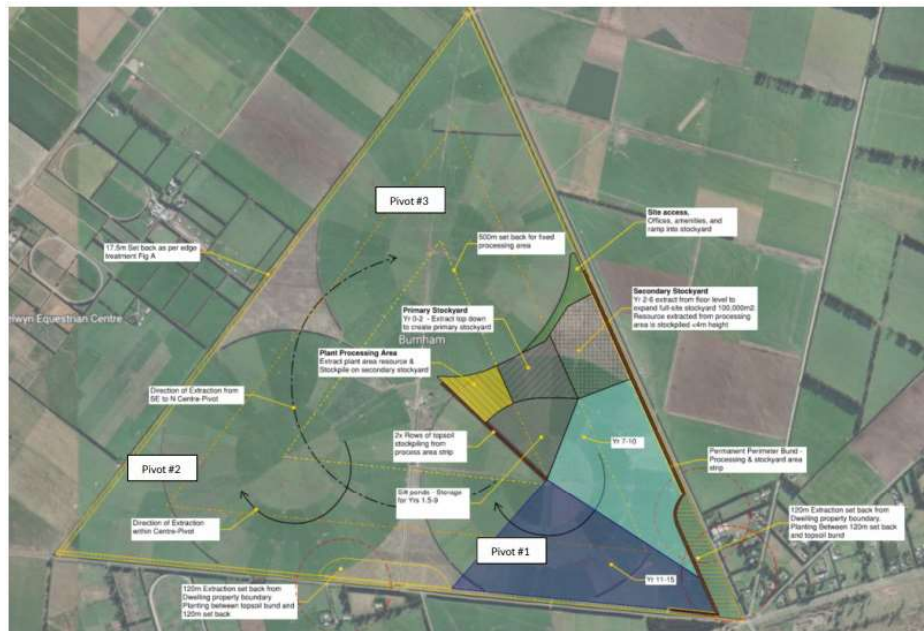
Figure 1: Quarry layout

The site will be extracted and rehabilitated in stages. Timeframes are estimated based on projected demand and are subject to change:

- Years 1-6. Initial extraction. These areas will be used to set up the processing plant area, stockyard, and amenities for the life of the quarry – as a result they will not be rehabilitated until the site's end of life.
- Years 7-10. Extraction towards the SE corner of the site. From the start of this stage the quarry will be progressively rehabilitated.
- Years 10+. Extraction and rehabilitation in a clockwise direction around pivot #1, then into pivot #2 and finally pivot #3, as shown in Figure 1. Areas between and beside pivots will be extracted and rehabilitated with each move into new areas enabling reinstatement behind the leading edge.

The gravel extraction will be staged with removal of topsoil and subsoil (referred to as overburden in other reports for the site) undertaken incrementally. Staging the gravel extraction reduces the short term loss of productive land on the site and reduces the volume of soil requiring stockpiling and the time the soil is stockpiled. This in turn reduces the potential for soil degradation and soil loss (by overland flow runoff or wind).

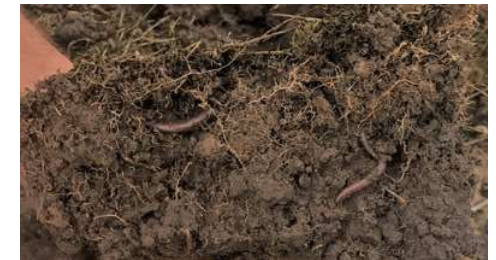
Condition	Description	Score
Good condition	Good distribution of nutty aggregates with no significant clodding.	2
Moderate condition	Soil contains some nutty aggregates but also a significant proportion of coarse firm clods and/or fine non-aggregated soil.	1
Poor condition	Very few nutty aggregates. Soil dominated by coarse compacted, very firm clods and/or fine non-aggregated soil.	0

Figure 2. A high score (2) may look like the sample above.

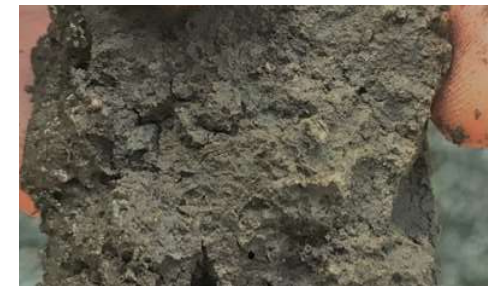
Figure 3. A low score (0) may look like the sample above.

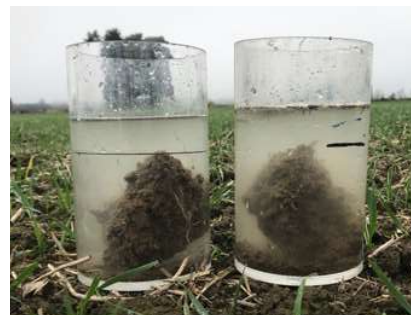
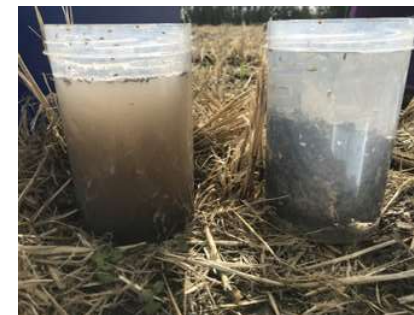
* Minimal pore spaces due to extreme compaction may also result in low turbidity. Refer to observation notes and score 2 if you suspect low turbidity is a result of compaction (if it is, give a score of 0).

Figure 4. Samples showing the difference between a high and low turbidity score.
